SECTION 2.2 Site Investigation Reports

2.2.6 Drainage Report

Project Name: Wingates Bolton Unit 3
Project Description: WinCan Import in Miraculix Standard
Project Status: On Site
Project Date: 01/05/2024
Inspection Standard: MSCC5 Sewers & Drainage GB (SRM5 Scoring)

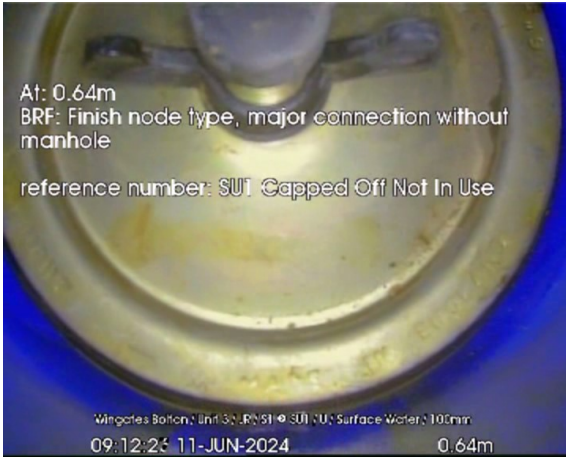
SU1X_fe61c4cf-4d94-4bfc-8120-d5a6b231868b_20240614_170410_886.jpg, 00:00:11, 0.64 m

Finish node, major connection without manhole, reference: SU1, Capped Off Not In Use

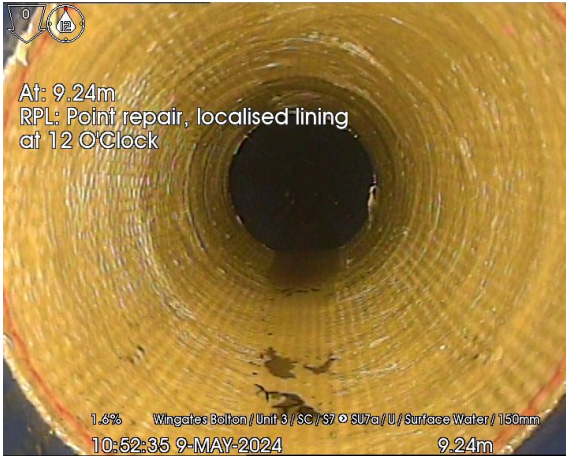
S7 - SU7a_9-24m_105235.jpg, 00:01:00, 9.24 m
Point repair, localised lining at 12 o'clock

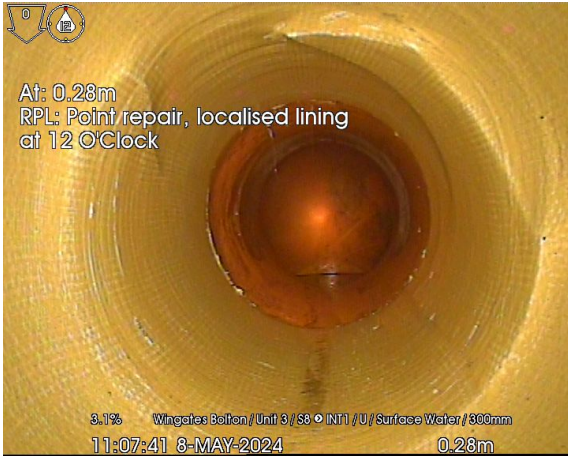
S8 - INT1_0-28m_110741.jpg, 00:00:08, 0.28 m
Point repair, localised lining at 12 o'clock

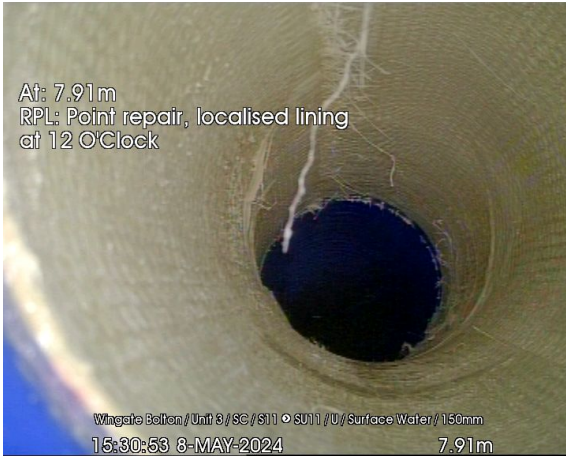
S11 - SU11_7-91m_153053.jpg, 00:00:38, 7.91 m
Point repair, localised lining at 12 o'clock

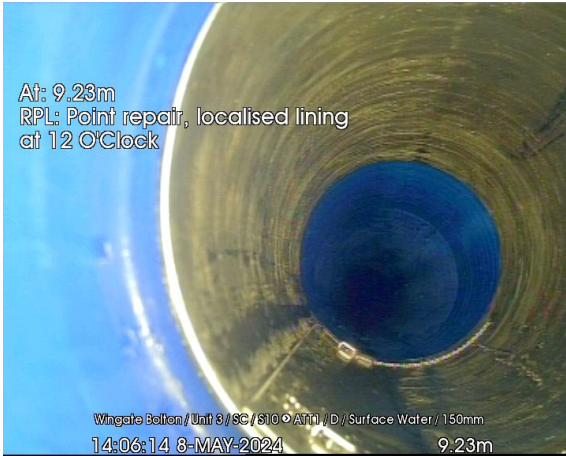
S10 - ATT1_9-23m_140614.jpg, 00:00:39, 9.23 m
Point repair, localised lining at 12 o'clock

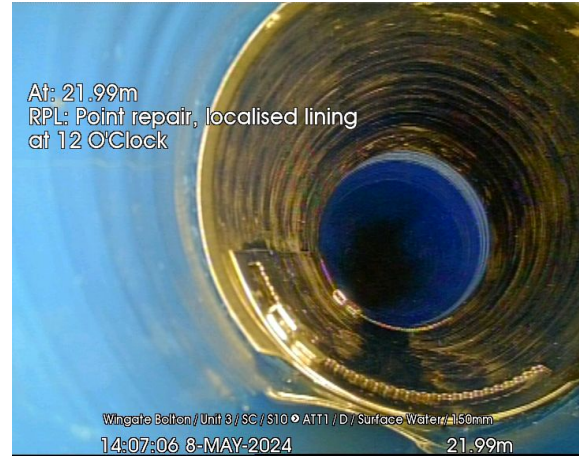
S10 - ATT1_21-99m_140706.jpg, 00:01:24, 21.99 m
Point repair, localised lining at 12 o'clock
